METRO VANCOUVER

# REGIONAL WATER SUPPLY SYSTEM LIFELINE STUDY: SEISMIC VULNERABILITY ASSESSMENT

FEBRUARY 10, 2022

FINAL

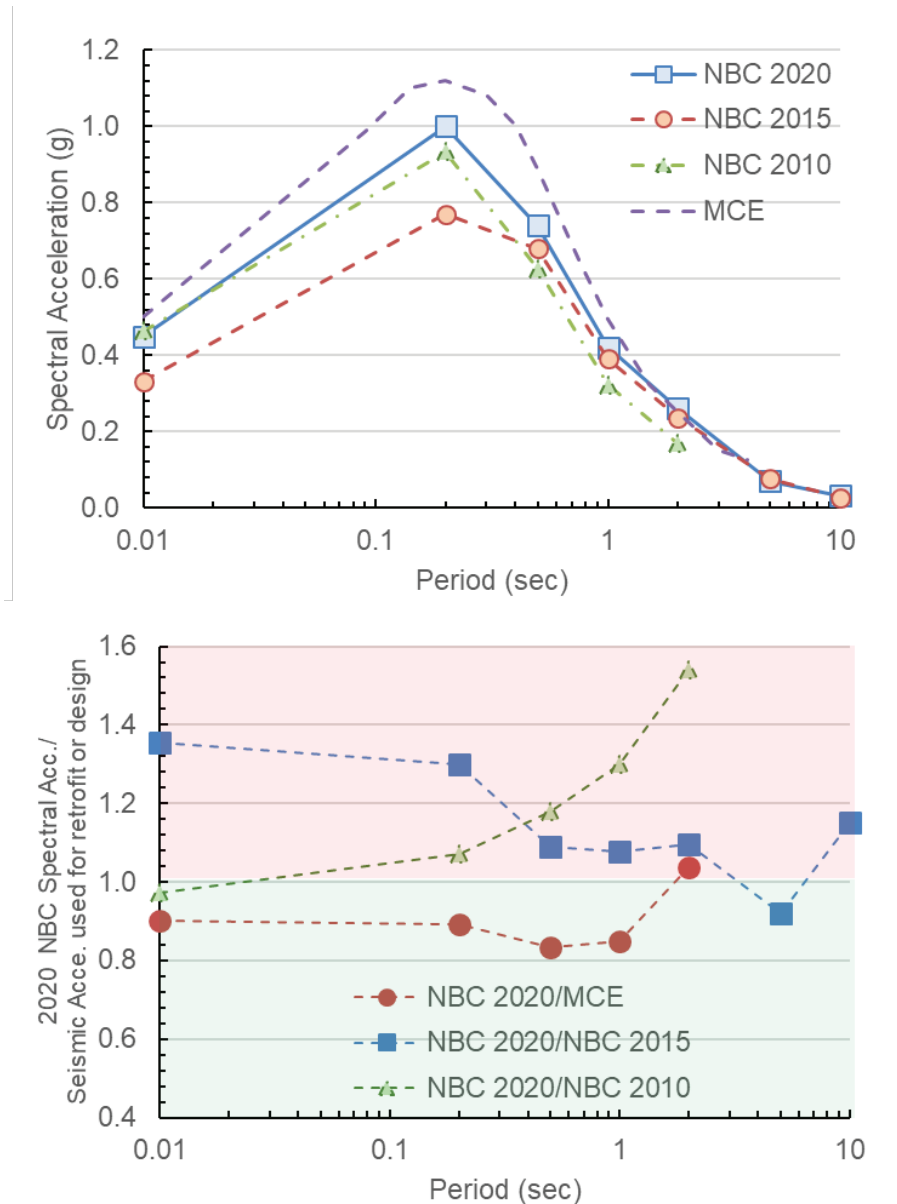
Figure 2-1 compares the firm ground seismic accelerations obtained from the fourth, fifth and sixth-generation seismic hazard models for a location on Burnaby Mountain. For comparison purposes, the MCE seismic demands adopted for the seismic retrofitting of the Kennedy Park reservoir are also shown. Similar comparisons for the remaining 11 locations are included in Appendix A of this report. Note that comparisons were made with respect to the “firm ground” seismic hazard values.

**Figure 2-1: Comparison of firm-ground spectral accelerations from different design codes**

- In the long period range: The seismic demand in the 2005 and 2010 NBC versions is significantly smaller than the 2020 NBC values. This may not provide a true reflection of the differences in seismic demand since the seismic demand from the Cascadia subduction sources, which has a greater impact on the long period seismic hazard, were accounted deterministically in the fourth-generation seismic models. In the long-period range, the difference between 2015 NBC and 2020 NBC is relatively minor (about 10%).

In general, the design seismic demand is expected to increase with the adaptation of 2020 NBC as discussed further in Section 5.4.3 of this report. For facilities, the increase will be influenced by the period of the structure.

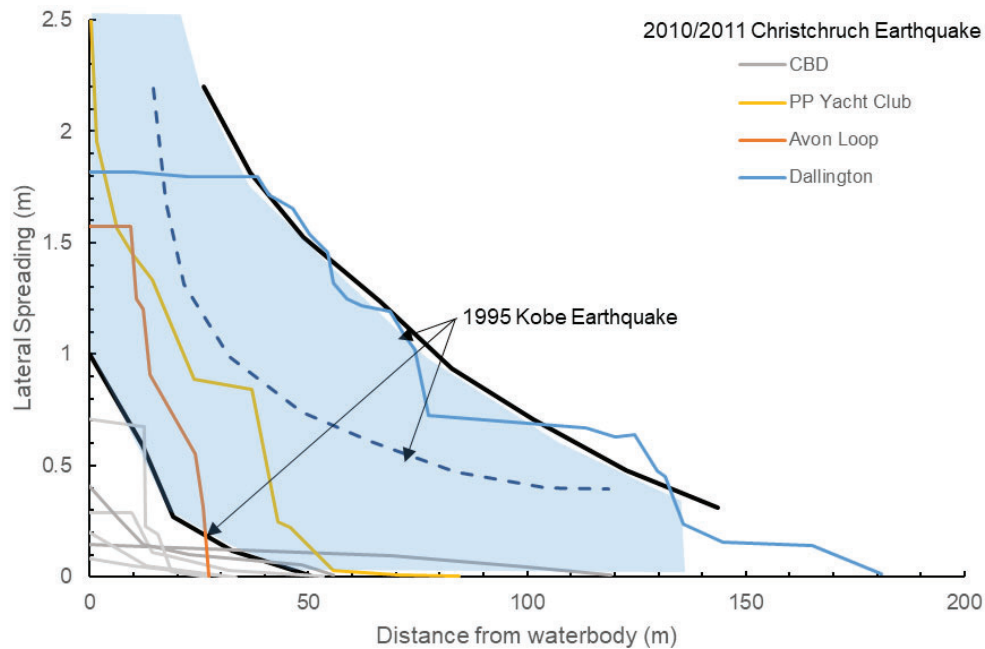
Generally, the largest horizontal ground displacements are observed near water bodies and decrease away from the water body. For example, ground displacement profiles measured during the 1995 Kobe and 2010/2011 Christchurch earthquakes are shown in Figure 2-3.

**Figure 2-3: Distribution of lateral spreading estimated during the 1995 Kobe and 2010/2011 Christchurch earthquakes**

The impacted zone generally extends 150 to 250 m from the free face. Beyond this point, the lateral spreading is largely governed by localized topographical features. Small slumps and soil failures could occur along drainage ditches/channels, although such failures are not a threat to pipes buried at a deeper depth than the invert of the drainage ditch. The length of pipeline exposed to such localized ground movements is very limited; therefore, the soil load is typically not sufficient to cause significant stresses/strains.

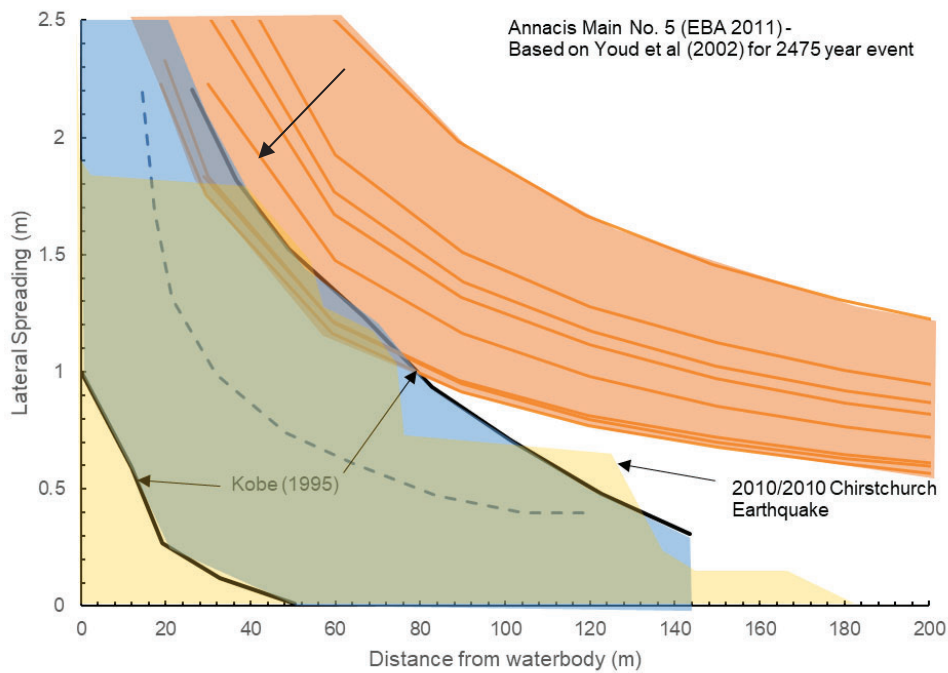
As highlighted in the following sections, numerical modeling (time-history analysis) has been conducted for most of the critical pipelines, while other pipes include ground movement predictions developed using simplified methods (e.g., Youd et al. 2002, 2009). For example, Figure 2-4, shows the range of lateral spreading displacements predicted using the Youd et al. (2002) method for Annacis Main No. 5 (after EBA, 2011). The actual lateral spread displacements measured during 1995 Kobe and 2010/2011 Christchurch events (Cubrinovski et al., 2012) are also shown for comparison.

**Figure 2-4: Estimated lateral spreading displacements for Annacis Main No. 5 (after EBA, 2011). Actual lateral spreading measured during the 1995 Kobe and 2010/2011 Christchurch earthquakes are also shown for comparison.**

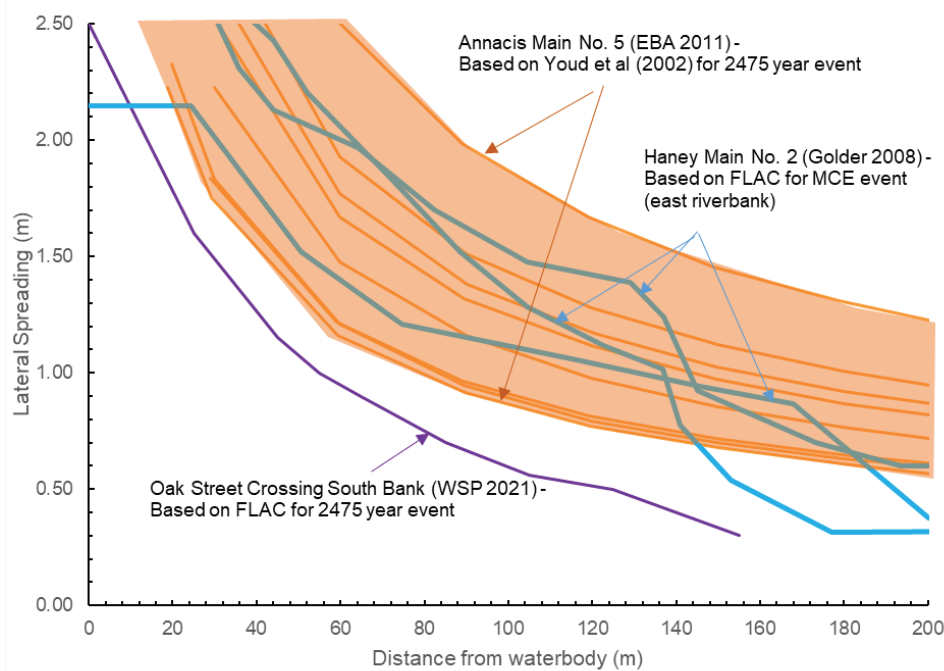
The magnitude of lateral spreading can also be estimated using advanced ground deformation analysis (e.g., FLAC or PLAXIS). Figure 2-5 shows some of the lateral spreading profiles estimated using the 2D FLAC for Haney Main No. 2 and Cambie-Richmond Main near Oak Street bridge. For comparison purposes, the displacement profiles estimated using the Youd et al. (2002, 2009) method are also shown. Somewhat similar trends can be observed despite the differences in locations, soil conditions, earthquake time histories and analysis approaches. We are aware that soil movements extending to deeper depths can sometimes be predicted using numerical modeling forcing the watermain to adopt a deeper profile to avoid soil layers that contribute to the movement. Such observations are not consistent with simplified empirical methods that do not suggest ground displacements in deep non-liquefiable soils or below a certain depth (e.g., Youd, 2018).

**Figure 2-5: Estimated lateral spreading displacements using FLAC (after Golder 2008 and WSP 2021). Lateral spreading estimated using the Youd et al. (2002, 2009) are also shown for comparison.**

2. Marpole Crossover Main – The lateral spreading profile was assumed to be similar to the Oak Street bridge considering its proximity to the watermain (see Figure 2-5).

3. Angus Drive Main between Fraser Park to Southwest Marine Drive – Given the proximity to the Oak Street bridge, lateral spreading profile was extracted from 2D FLAC analysis conducted for this bridge (see Figure 2-5).

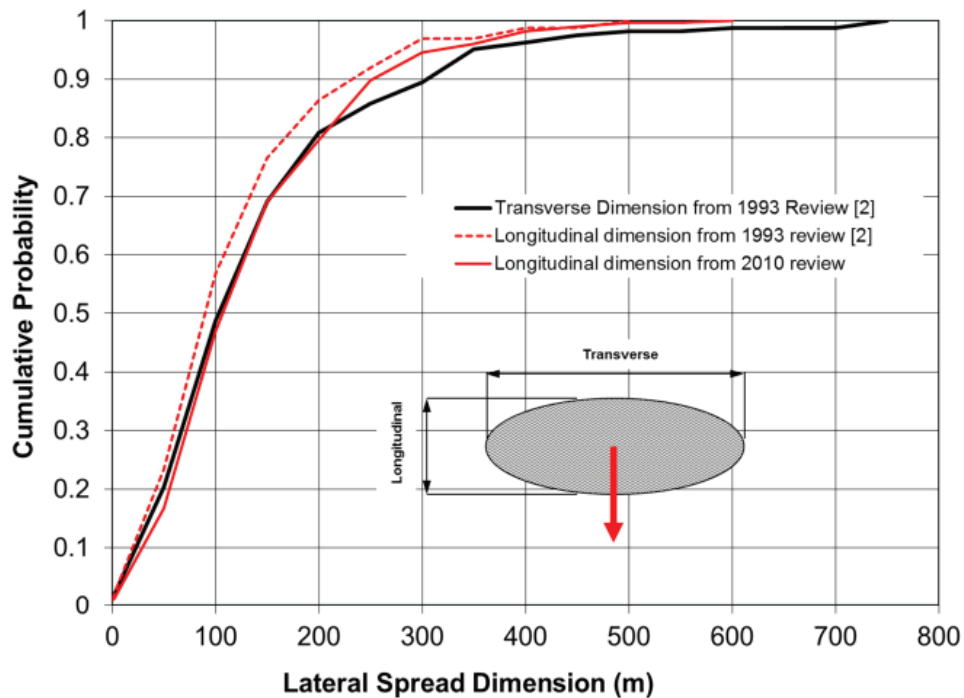
The cumulative probability distribution of the width of the lateral spreading zone is shown in Figure 2-7 (Honegger, et al. 2014). A width of lateral spreading zone associated with a 50 percent cumulative probability is 100 m. This information is used in the pipe-soil interaction analysis discussed in Section 4.4.3.

**Figure 2-7: Width of lateral spreading distribution from past earthquakes (adopted from Honegger et al., 2014).**

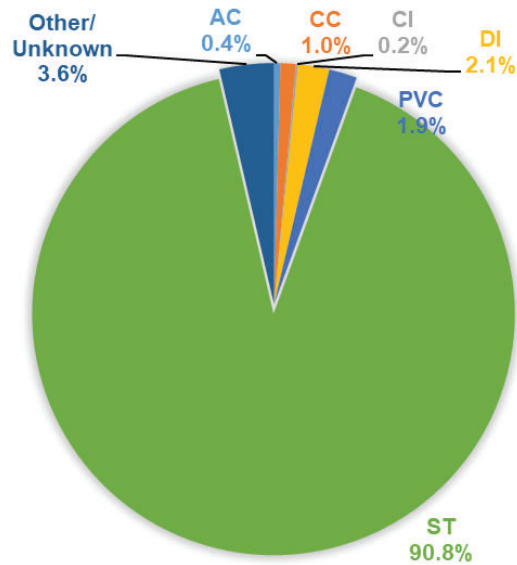
Figure 4-1: Pipe material types in Metro Vancouver's water supply system

The following describes the factors impacting the seismic vulnerability of watermains and how they were incorporated into the vulnerability assessment. As indicated previously, approximately 90 percent of Metro Vancouver's transmission mains consist of large diameter steel pipes (see Figure 2-9). For this reason, the following discussion is primarily focused on factors that impact such pipes.

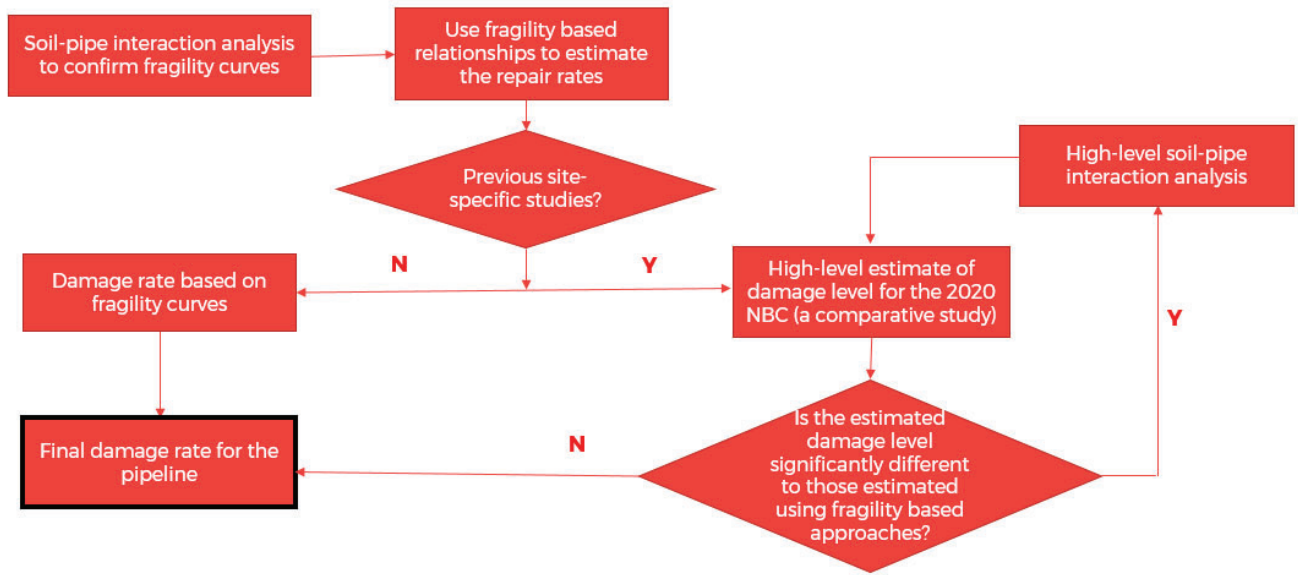
As highlighted earlier, several site-specific studies are available for most of the key water mains. Therefore, it is paramount to maximize this information when estimating the extent of damage. With this intent, the following framework was adopted (Figure 4-3) for estimating the pipe damage rates due to PGD.

Figure 4-3: Framework adopted to estimate the pipeline damage rates due to PGD.

A key advantage of this approach is to utilize PSI analysis to estimate damage rates because the existing fragility curves were developed from a smaller database of large diameter welded steel pipes (see discussion in Section 4.3.2). Despite the benefits of PSI analysis, it is not always possible to rely entirely on a site-specific analysis to estimate the level of damage. For example, site-specific PSI analysis is not typically conducted for complex pipe configurations or at every discontinuity to assess the vulnerability at these locations. Although the damage occurring at these locations may be minor (i.e., a leak) compared to an area with a well-defined ground failure, such failures cannot be ignored. For this reason, if the damage rates predicted from site-specific analysis and fragility-based curves showed significant differences, further scrutiny was given to identify the root-causes and select the most appropriate damage rate. Some of these scenarios are discussed later in this report.

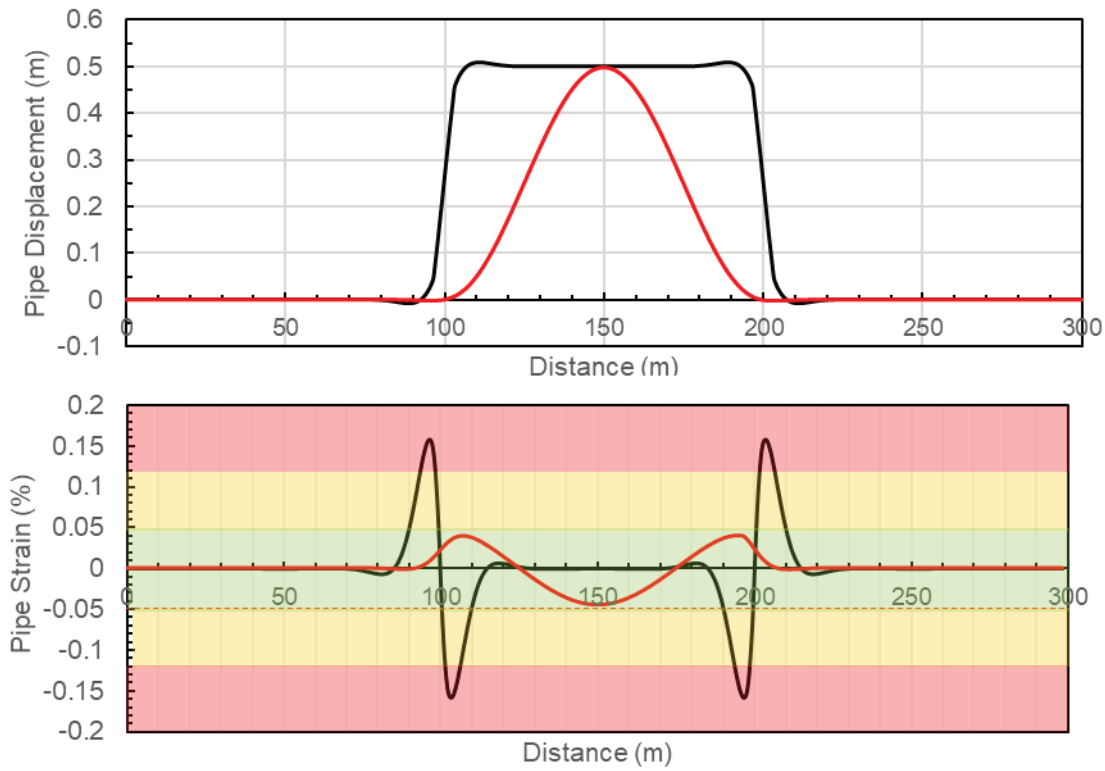
As an example, Figure 4-6 shows the pipe deformations and pipe strains estimated for a 914 mm x 6.4 mm watermain buried at a depth of 2 m. The horizontal ground displacement is 0.5 m, and the width of PGD was considered as 100 m.

The red, orange and green areas represent the different strain thresholds considered in Table 4-4 for lap welded joints. In this case, the pipe strains induced from the abrupt ground deformation profile are more severe than the cosine ground deformation profile. The higher strains are experienced near the slide boundaries, while the cosine shaped PGD profile indicates strain less than 0.05 percent for the entire pipe length. For the abrupt ground deformation profile, 16.8 m of pipe length falls within 0.05 to 0.12 percent strain range, while 19.2 m of pipe length is within 0.12 to 0.24 percent strain range. As explained above, these lengths represent  $d_1$  and  $d_2$  in Equation 5 for estimating  $RR_{PGD}$ .

Figure 4-6: Estimated pipe deformation shapes and bending strains for 0.5 m of lateral spreading (914 mm x 6.4 mm steel pipe)

Both cosine and abrupt ground deformation shapes were considered in the PSI analysis. The largest damage rate out of the two ground movement profiles was selected for subsequent calculations. Except for certain larger diameter pipes subject to relatively smaller PGD, abrupt ground displacements were found to provide the highest damage rates.

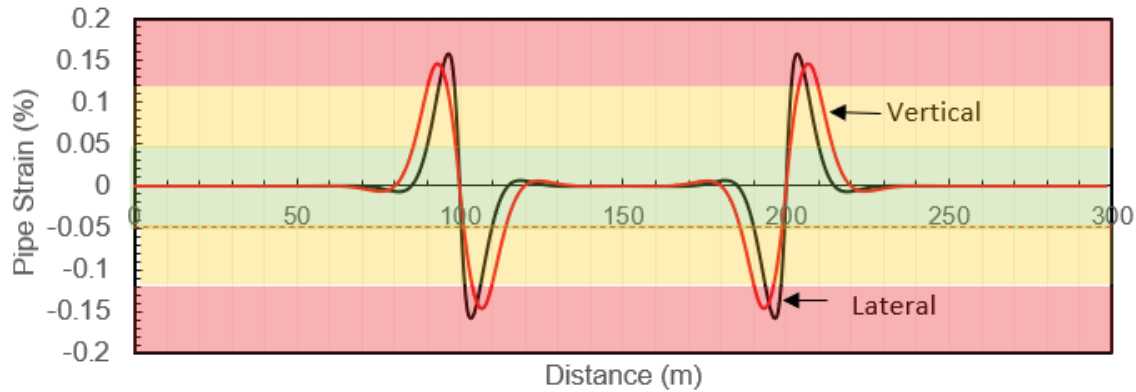
The differences in damage rates estimated in the vertical and lateral directions can be explained by comparing the bending strain distributions (see Figure 4-8). The stiffer soil spring in the lateral direction increases will cause strain concentration within a narrow segment of the pipe although a slightly larger peak strain is induced in the pipe. In contrast, the relatively softer soil spring in the vertical direction will distribute the bending strain over a longer pipe length (i.e., more pipe length in the orange zone), although the maximum flexural strain is smaller. The results cannot be generalized for all displacement ranges and pipe sizes. Above observation is mostly true for relatively smaller ground displacements. As the ground

magnitude of ground displacement increases, the lateral soil loading is expected to result in a higher failure rate than in the vertical direction.

**Figure 4-8: Bending strains measured for soil loading occurring in vertical and lateral directions (914 mm x 6.4 mm diameter steel pipe).**

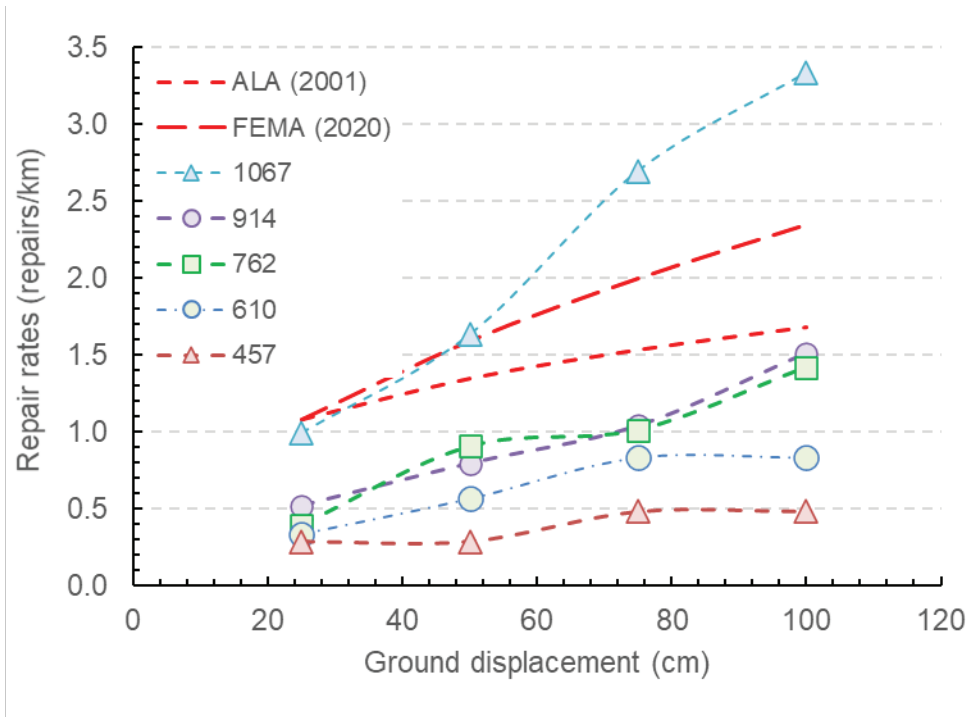
Figure 4-10: Damage rates estimated from the proposed pipe-soil interaction analysis and fragility curves provided in ALA (2001) and FEMA (2020) for different pipe diameters and PGD values in the vertical direction

A summary of the key observations is given below:

- In general, the damage rates estimated using the ALA (2001) fragility curves are higher than those estimated using PSI analysis up to about 1.5 m of lateral spreading. Beyond this displacement, the damage rates estimated for larger diameter pipes using ALA (2001) are somewhat less than those estimated using PSI, although the difference is not significant considering other uncertainties associated with this assessment. The damage rates estimated using FEMA (2020) are considerably higher than those estimated from PSI and ALA (2001), especially at larger PGD values.

- For diameters exceeding 1m, a larger damage rate is predicted using PSI than those estimated using empirical fragility relationships. The difference increases as the ground displacement increases.

- ALA (2001) damage rates are somewhat insensitive to the PGD value. For example, an order of magnitude increase in PGD only produces a factor of roughly two to three times the increase in failures. This may be attributed to the fact that once yielding occurs at a certain pipe location, the remaining sections are protected from damage since most of the deformation is localized to this location. PSI analyses indicate a somewhat higher sensitivity to the magnitude of PGD but it greatly depends on the pipe diameter and other factors.

- Besides some exceptions, PSI analysis indicates that damage rate increases with the pipe diameter, consistent with the explanation given by Ni et al. (2018). However, it should be noted that D/t and H/D ratios are not the same for each case; therefore, PSI results may not provide a true reflection of the pipe diameter impact if D/t and H/D ratios remains the same. However, it is considered more pragmatic to consider the actual conditions observed in Metro Vancouver's transmission mains instead of carrying out such analysis for hypothetical scenarios with academic interest. As stated earlier, better construction and quality control measures adopted for larger diameter pipes are not reflected in the PSI analysis, although they can have a significant impact on the relative vulnerability.

- A key information extracted from the PSI analysis is the relative vulnerability of the pipe barrel and weld connection. According to the above formulation, the number of damages expected in the pipe and weld can be calculated separately. Such comparisons cannot be made using the fragility relationships. PSI analysis indicates that about 90 to 95 percent of failures would occur at weld connections. This was in the order of 60 percent during the 1994 Northridge earthquake and 80 percent during the 1995 Kobe earthquake. During the 2016 Kumamoto earthquake, in pipes larger than 600 mm, only about 10 percent of the damages occurred in the pipe barrel. This indicates that PSI predictions are somewhat consistent with observations from actual earthquakes, implying that relative failure probabilities selected for pipe and weld connections are reasonable.

The analysis described above was repeated for several pipe diameters and different PGD values in the horizontal and vertical directions, and the results are presented in Figures 4-9 and 4-10, respectively. Note that D/t and H/D ratios are not similar in these scenarios, but they represent the most likely conditions observed in Metro Vancouver’s transmission mains. The pipe diameters, pipe wall thicknesses and pipe burial depths considered in this assessment are summarized in Table 4-5. For comparison purposes, the repair rates estimated using ALA (2001) and FEMA (2020) are also shown. The comparison does not consider any corrosion, age and long-term settlement impacts.

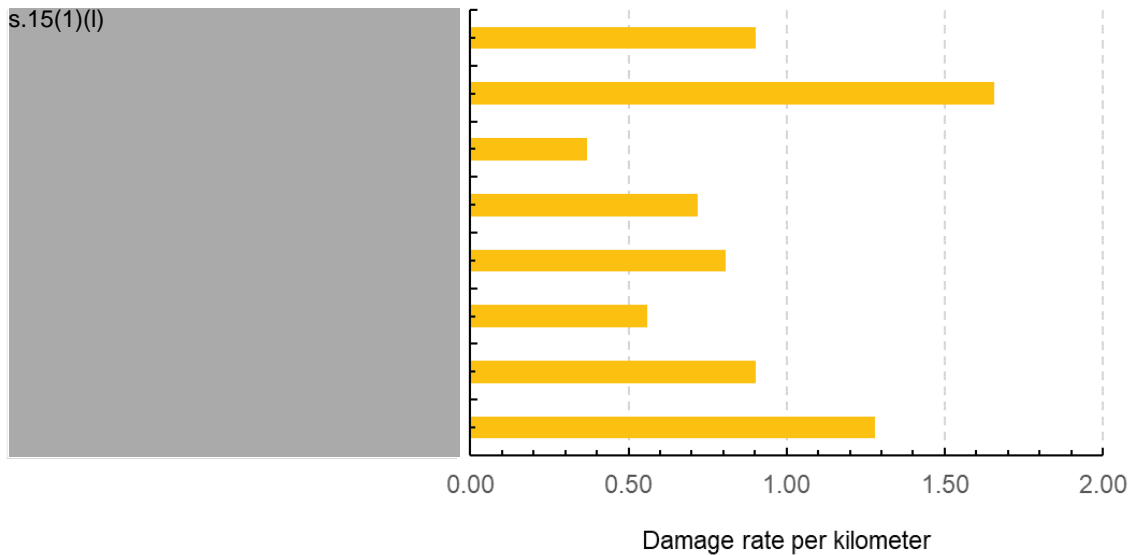
Figure 4-11: Damage rates estimated from PSI and those selected for estimating the damage rates for different water mains subject to post-seismic settlement.

- The lowest damage rate was estimated for the s.15(1)(l) constructed in 2017. Large damage rates were estimated for the older mains including s.1. The damage rate of s.15(1)(l) is exacerbated by concerns related to ongoing settlements in the area.

these pipes based on the criteria given in Table 4-1. Figure 4-11 shows the different damage rates estimated for some of the key water mains in these areas.

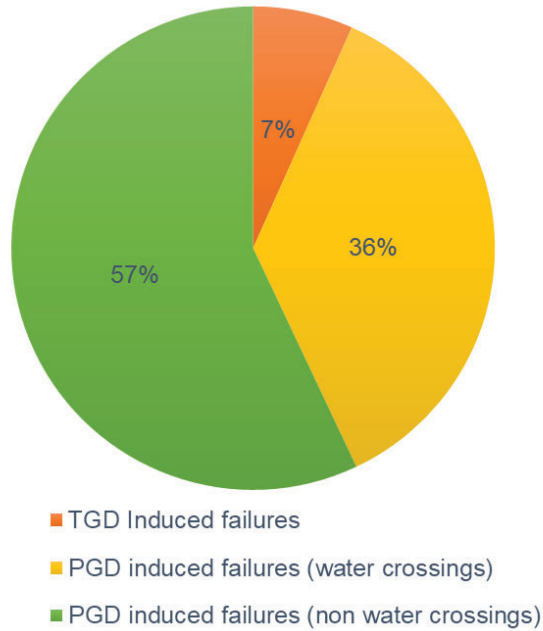
Figure 4-13: Breakdown of failures into different modes.

- For a 1 in 2475-year return period, the regional-scale assessment has estimated a total of 129 leaks and 138 breaks in the Metro Vancouver’s water transmission network. The estimated damage rate is 0.54 failures/km when the total pipe length is considered. As expected, the highest concentration of failures was estimated to occur in areas susceptible to liquefaction and PGD. For example, 249 failures would occur in areas prone to liquefaction or landslides (i.e., 1.98 failures/km), which includes the water crossings. When water crossings are excluded, the damage rate becomes 1.10 failures/km in areas prone to PGD.
- As shown in Figure 4-13, approximately 93 percent of the failures can be attributed PGD induced failures. Also, approximately one-third of failures can be attributed to failures occurring near water crossings.

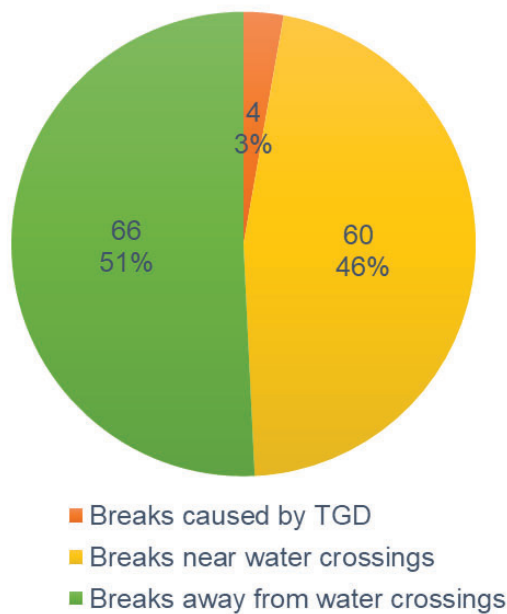
Figure 4-14: Breakdown of breaks occurring in transmission mains

- A total of 129 breaks have been estimated, which is almost entirely (approximately 96 percent) attributed to PGD. Out of which, approximately 60 percent would occur near/at water crossings (see Figure 4-14). It is possible that number of breaks have been overestimated for steel watermains due to the assumed split between breaks and leaks. There are no reliable statistical data to improve this value and it was considered conservative to overestimate the breaks instead of considering them as leaks (see discussion on Serviceability Index in Section 4.4.1).

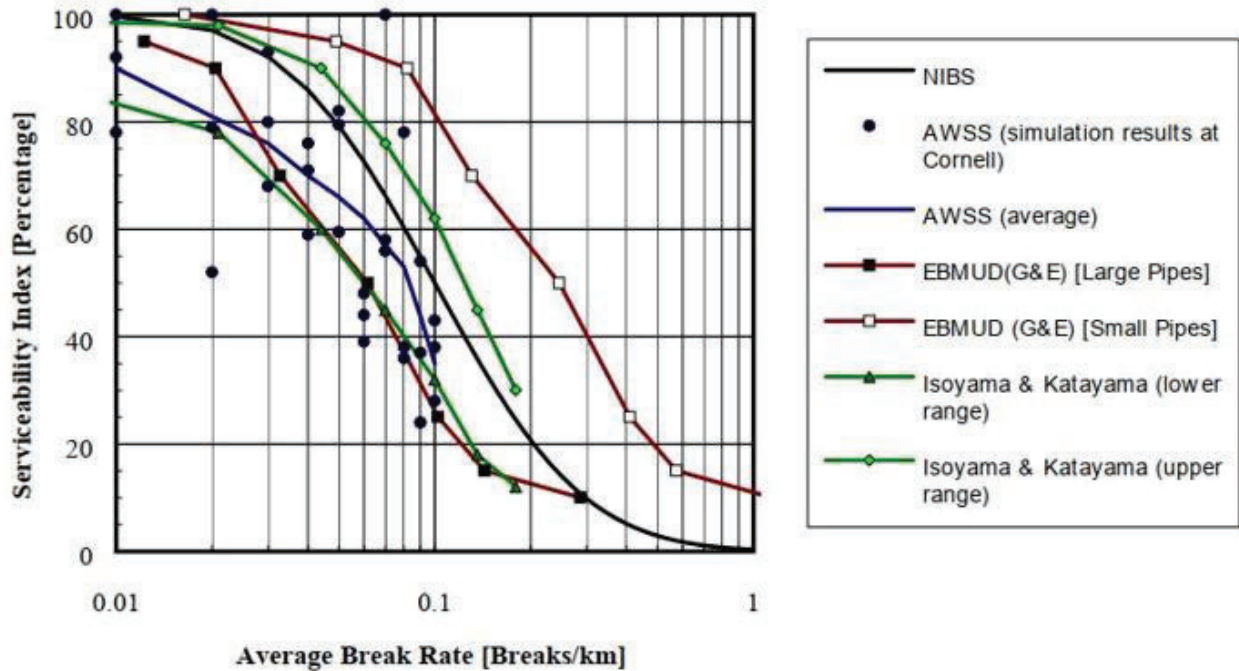
Figure 4-16: Serviceability and average break rate relationships

Typically, the breaks per kilometer of pipe is considered as a good indicator to determine the serviceability of a watermain after an earthquake. The serviceability levels estimated by different agencies and scholars are shown in Figure 4-16. The serviceability level relationship for Metro Vancouver's watermains may be different and it should be estimated from a separate study after considering the local conditions. However, for the purpose of identifying transmission mains with a high vulnerability rating, the serviceability relationship proposed by EBMUD for larger diameter pipes was considered. Note that the overall break rate for the entire pipe may not provide a true indication of the highly vulnerable sections if the impacted pipe length is only a fraction of the total pipe length. For this reason, pipe sections are divided into sections to depict the sections with high seismic vulnerability (see Table C4 in Appendix C).

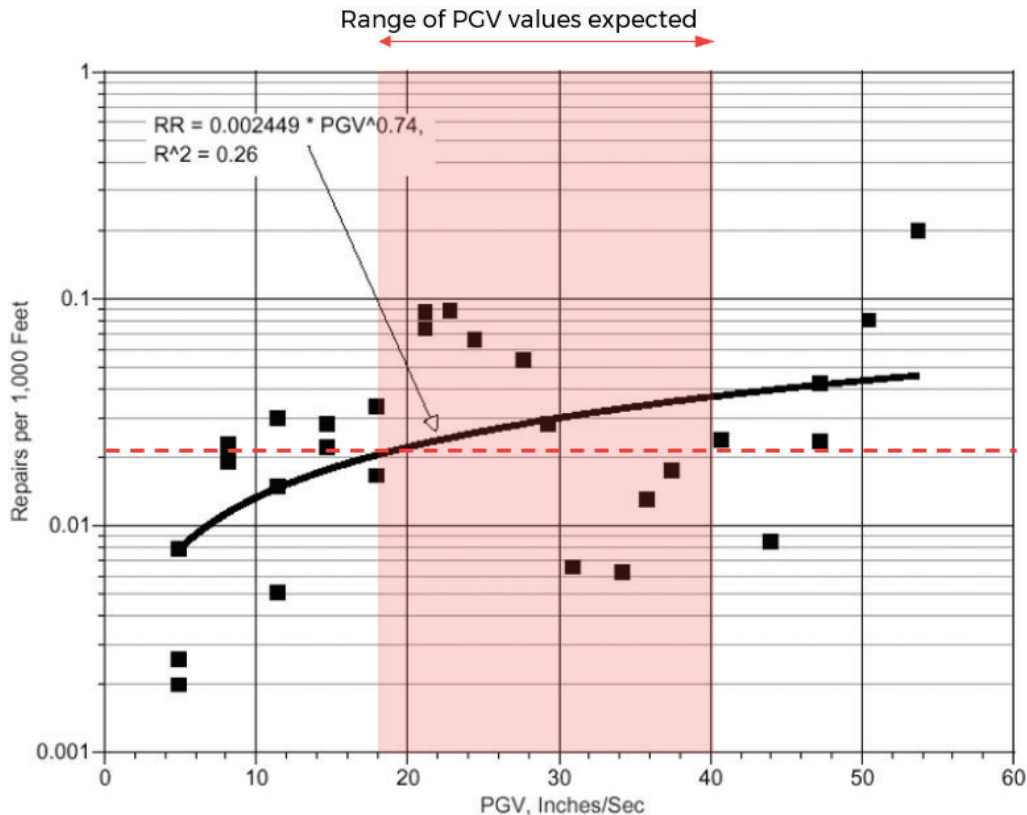
Figure 4-17: TGD induced damage rate from the current study compared against those measured during the 1994 Northridge earthquake (figure background adopted from ALA 2001)

The overall TGD induced damage rate from the current study is 0.04 failures/km (0.012 failures/1000 feet). This is shown in Figure 4-17 along with the range of PGV values estimated for a 2475-year seismic event occurring in the Greater Vancouver region. The figure background includes data from the 1994 Northridge earthquake for all pipe material types.

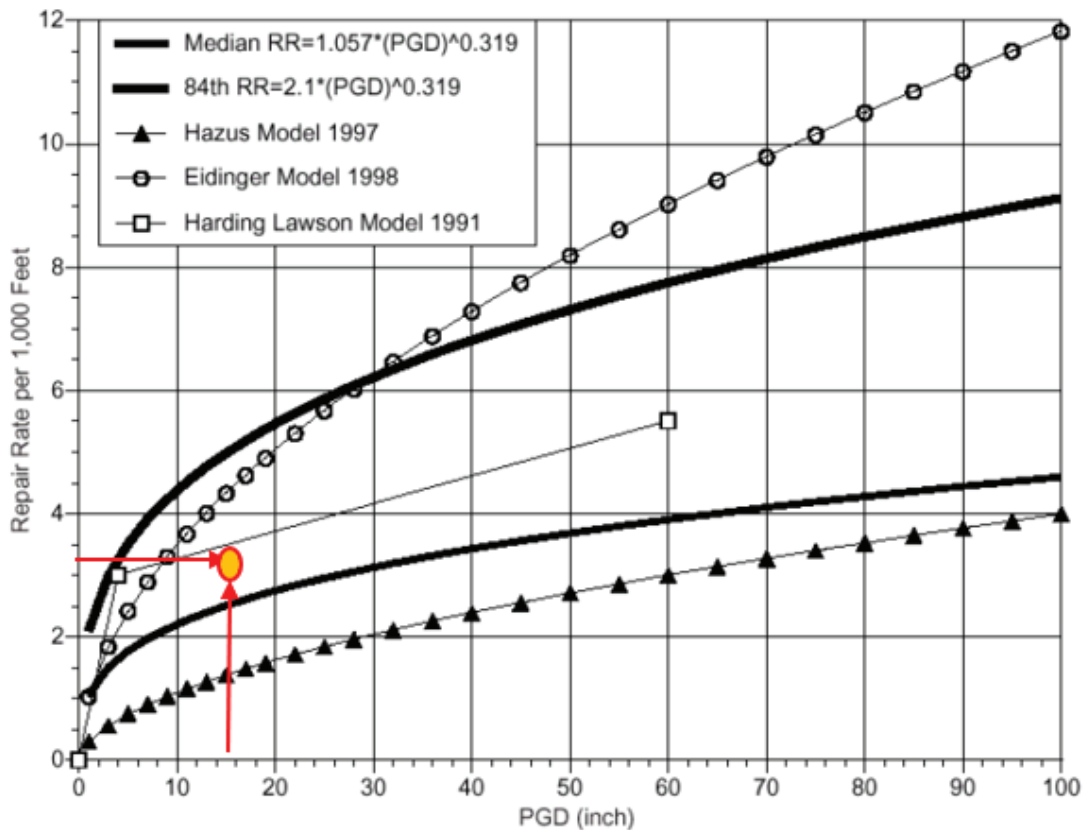
Figure 4-18: PGD induced damage rate estimated from the current study (divided by 0.3) compared against empirical fragility based relationships (figure background adopted from ALA 2001).

The weighted average PGD for this study is about 38 cm (15.3 inches) and the corresponding damage rate is 1.1 failures/km (or 0.34 failures/1000 feet). Figure 4-18 shows several empirical fragility based relationships recommended for estimating the PGD induced damages. Those relationships are applicable for brittle pipes, and for ductile pipes, the damage rate is expected to be about 0.3 times of those recommended for brittle pipes (see Section 4.4.3). Majority of pipes included in Metro Vancouver's

transmission network are considered as ductile. Therefore, for comparison purposes, the damage rates estimated from this study was divided by 0.3 and plotted in Figure 4-18. Despite the approximate nature of this comparison, it is of interest to note that the damage rates estimated using the PSI based method (used in this study) fall within the range of damages estimated using different fragility based relationships.

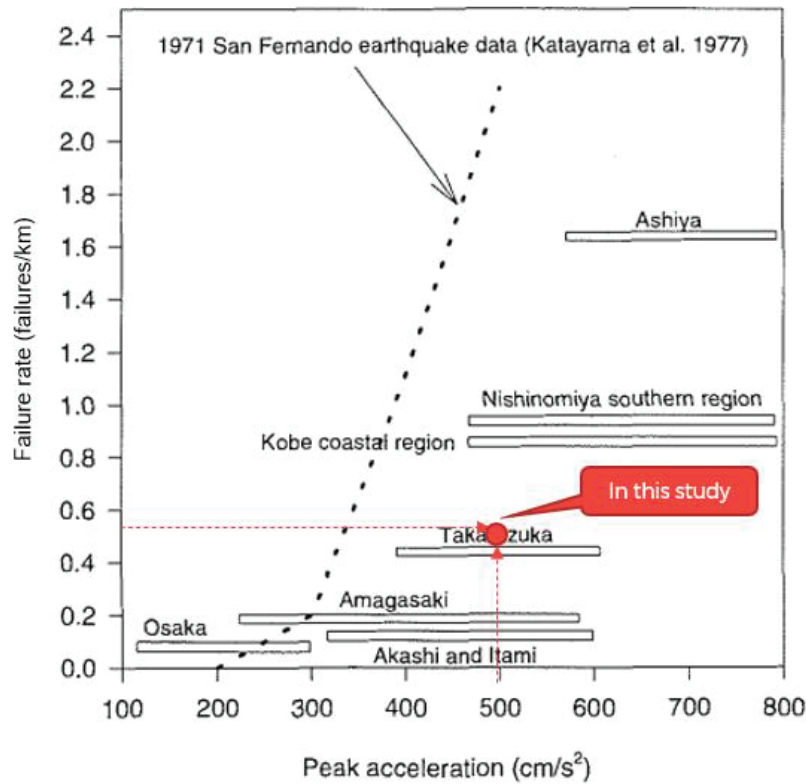
Figure 4-19: Pipe damage rates from Katayama et al. (1977) and 1995 Kobe earthquake (adopted from Kuraoka and Rainer, 1996).

As discussed earlier, there is considerable uncertainty related to the separation of damages caused by TGD and PGD in past earthquakes. For this reason, Ballantyne (1995) argued for the use of generalized pipe damage calculation without separating the damages into TGD and PGD categories. An example of this approach proposed by Katayama, et al (1975) where the damage rate is related to PGA (see Figure 4-19). It should be noted that the use of Katayama's relationship for this study will overestimate the damage rates because their database mainly consisted of brittle pipes.

Table 4-9 and Figure 4-19 also highlight the differences in damages that can be expected if a smaller intensity earthquake occurs in the Metro Vancouver region. For example, if the PGA is half of that considered for the 1 in 2475-year event, the damage rates can be several times smaller than that estimated for this study. Estimating the damage rates for different earthquake levels is beyond the scope of this study.

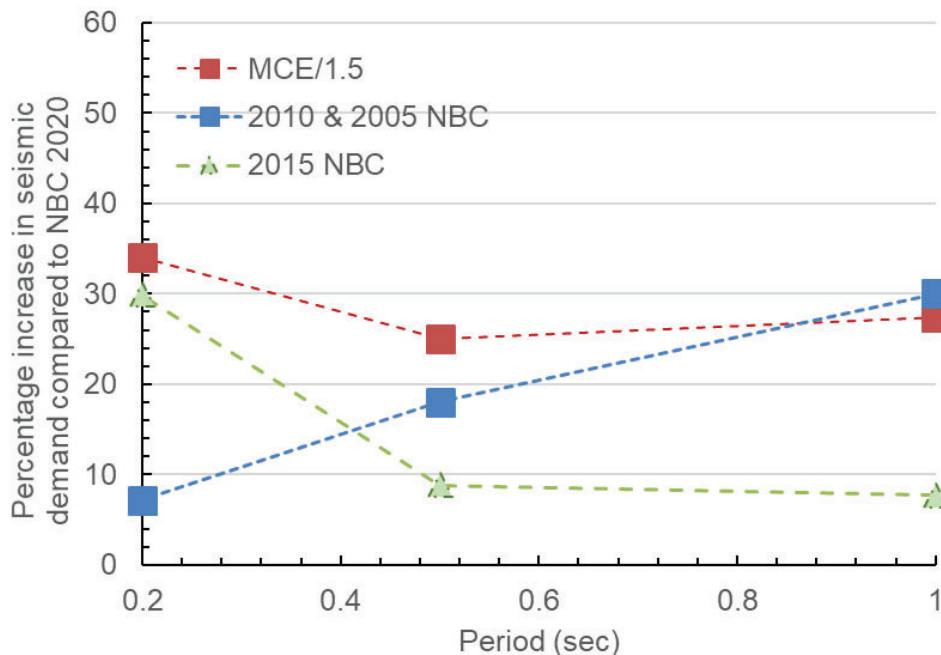
Figure 5-1: Percentage increase in seismic demand in 2020 NBC compared to MCE/1.5, 2010 & 2005 NBC and 2015 NBC

For pump station and reservoirs, the seismic event/design code and Importance Factor selected for design or seismic retrofitting are given in Tables 5-2 and 5-3. This allows a comparison to be made between the seismic “inertial” demands (mass times acceleration) considered for each structure against those expected in the 2020 NBC. As discussed in Section 2.2, the seismic demand is expected to increase with the adoption of the 2020 NBC as compared to previous seismic design codes. In general, this increase will range between approximately 10 to 25 percent for structures designed/retrofitted using the 2010 or 2005 NBC codes, with a larger increase expected as the period of the structure increases. For the 2015 NBC, the difference is approximately 10 to 30 percent with greater difference expected for shorter period structures. In both instances, the comparison has considered an Importance Factor of 1.5. The percentage increase in seismic demand, compared to 2020 NBC, is shown in Figure 5-1.

Note that Figure 5-1 shows the increase in seismic demand for the Burnaby Mountain area. Appendix A shows similar plots for several other locations within the Greater Vancouver area.

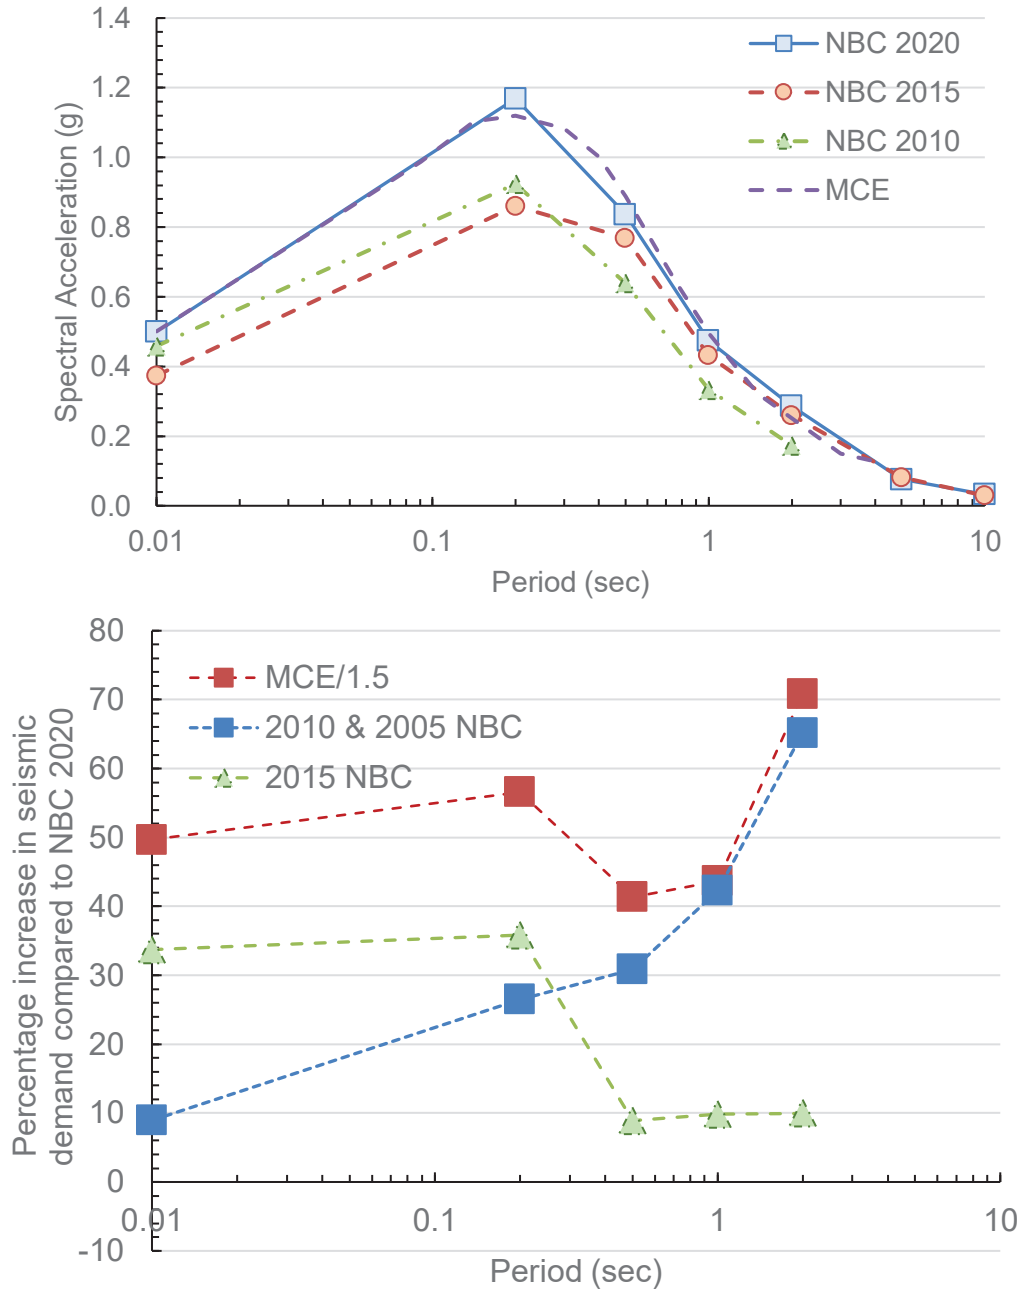
Figure A10: Comparison of firm-ground spectral accelerations from different design codes – Vancouver (Granville & 41 Ave), BC
